**ON-SITE INTEGRATED SEAT BELT INVESTIGATION**

**VERIDIAN CASE NO: CA01-043**

**VEHICLE: 2001 CHEVROLET K1500 PICK-UP TRUCK**

**CRASH DATE: JULY 2001**

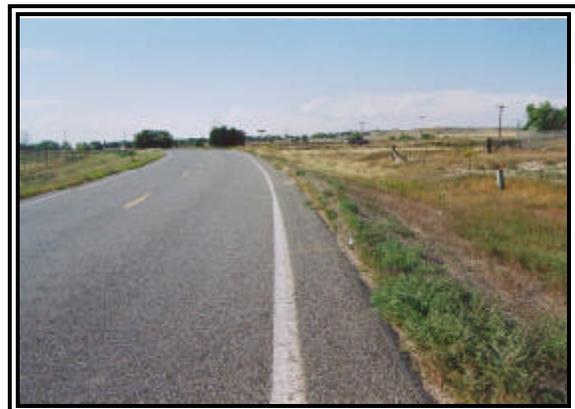
This single-vehicle crash occurred during the morning hours in July, 2001. At the time of the crash, it was daylight and the weather was not a factor. The road surface was dry. The crash occurred off the right (north) side of a two-lane east/west state route, located in a rural setting. There was a left curve for westbound traffic. **Figure 1** is a westbound trajectory view of the crash scene.

**Figure 1:** Westbound trajectory view at the roadside departure.

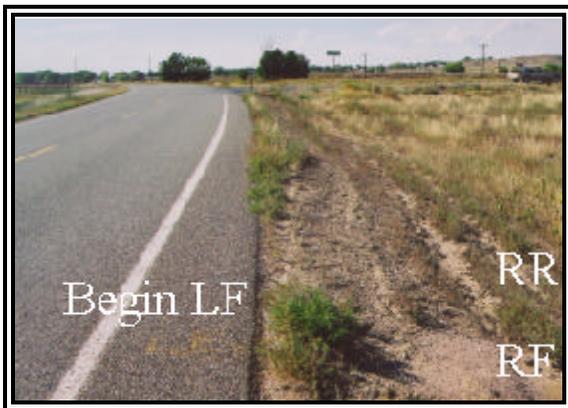
**Figure 2:** Westbound view of the Chevrolet’s yawing trajectory.

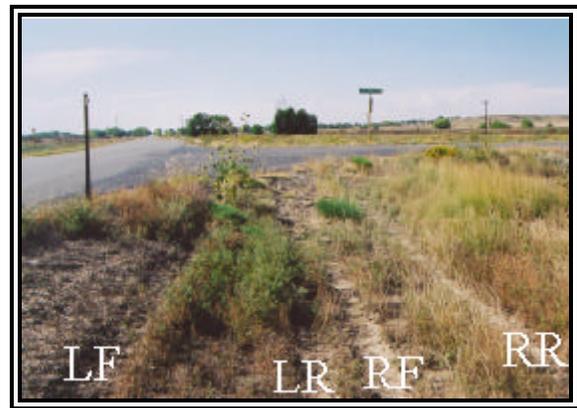
**Figure 3:** Trajectory view approaching the intersection.

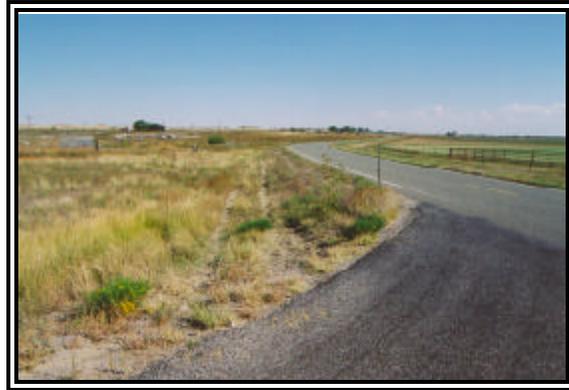
**Figure 4** is a look back view from the intersection of the yawing trajectory. As the Chevrolet climbed the embankment bordering the intersecting road, the positive slope of the terrain in the Chevrolet’s direction of travel caused the vehicle to vault. The slope of the embankment measured approximately +7 percent

in the westward direction. Inspection of the shoulder revealed the tire marks abruptly stopped and did not continue onto the asphalt pavement. The absence of the tire marks on the pavement indicated the vehicle had vaulted the roadway.

**Figure 4:** Look back view at the intersection.

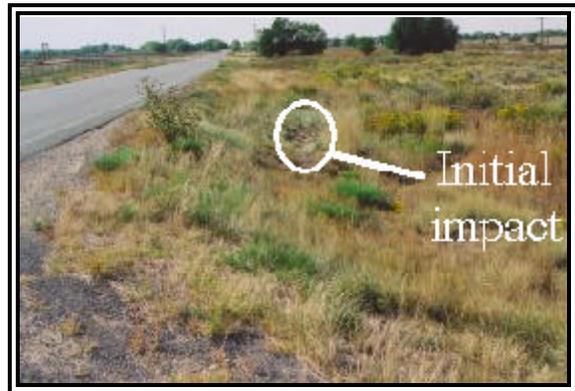
The Chevrolet vaulted approximately 29 m (96 ft) across the intersecting road and impacted the ground with its left front tire and suspension. The initial ground contact resulted in a gouge that measured approximately 3 m (10 ft) in length and 12 cm (6 in) in depth. The ground impact, **Figure 5**, fractured the left front shock absorber and separated the left front tire, wheel and brake assembly from the vehicle. The police investigator reported that the shock absorber was embedded in the ground. The impact did not command the deployment of the frontal air bag system. Air bag deployment was not warranted because the longitudinal component of the impact force was reduced by the combination of the vehicle's rotation (yaw) and the vertical nature of the impact. The vehicle's Event Data Recorder (EDR) did record a near deployment event. The complete EDR is attached to the end of this report.

**Figure 5:** View west of the intersection where the vehicle impacted and rolled.

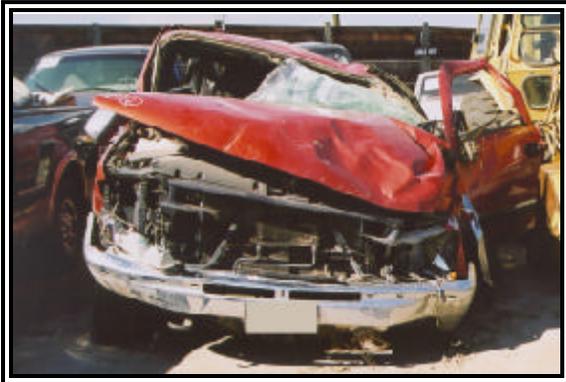
**Figures 6 through 8** are views of the damaged Chevrolet. The vehicle sustained direct damage to the undercarriage, roof and side planes consistent with an impact with a delineator post and an 8 quarter turn rollover. The right rear quarter-panel exhibited direct damage from contact with the delineator post. This contact pattern began 25 cm (10 in) forward of the right rear axle and extended rearward 113.0 cm (44.5 in). The lateral deformation was an estimated 3.8 cm (1.5 in) throughout the contact and measured 6.4 cm (2.5 in) in height. There was a white paint transfer noted within the contact pattern. The Collision Deformation Classification (CDC) of this damage was 12-RBMS-1.

The front undercarriage and the front cross-member in particular exhibited evidence of direct ground contact as a result of the vault. Dirt, grass and debris were embedded throughout the area. The left front wheel and suspension was dislodged from the vehicle during the initial ground contact. The front axle sheared at the transfer case, the lower control arm fractured at the frame and the upper control arm fractured at the ball joint. The direction of force to cause this damage was primarily in the 2 o'clock planar direction and had a vertical component. This force direction was consistent with the vehicle's counterclockwise rotation and trajectory. The CDC of the ground impact was 00-UFDW-1.

**Figure 6:** Front view of the Chevrolet.

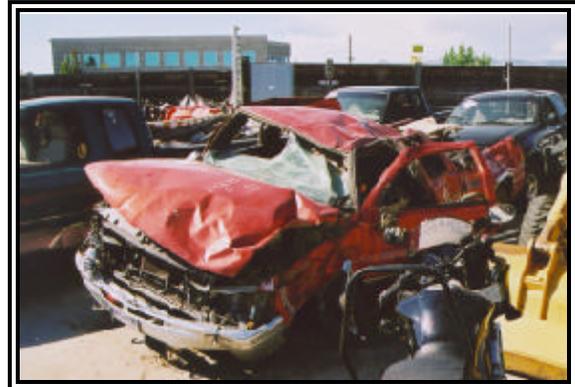
The overall longitudinal dimensions of the vehicle were unchanged indicating the roll was primarily lateral. The left front fender damage measured 64 cm (25 in) in length and was crushed laterally 26.7 cm (10.5 in). The left side doors were jammed during the rollover by deformation. The left front door was opened at the scene during driver extrication. The left rear door was forced open during the inspection. The right side doors were jammed shut and could not be opened. The windshield was fractured and all the side glazings and the backlight shattered during the rollover. The right side wheelbase dimension was unchanged. The CDC of the rollover damage was 00-TYDO-4.

**Figure 7:** Left front view of the damaged Chevrolet.

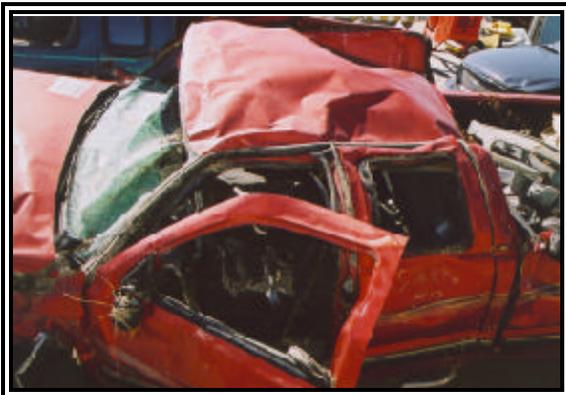
**Figure 8:** Left side view of the Chevrolet.

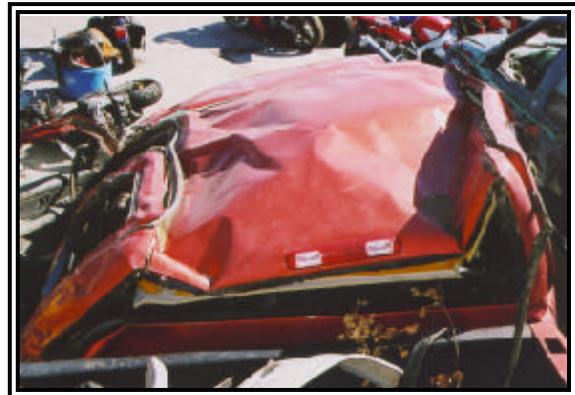
**Figure 9:** Rear view of the damaged roof.

The interior damage to the Chevrolet consisted primarily of vertical intrusion of the roof and lateral intrusion of the left roof side rail. The roof crushed down 41.9 cm (16.5 in) above the driver's seat and the left roof side rail deformed 24.1 cm (9.5 in) right as a result of the rollover. The left roof side rail impacted and compressed the driver's head restraint. The residual deformation of the seat back and head restraint measured approximately 15 cm (6 in). **Figures 10 and 11** are views of the driver's seat back deformation.

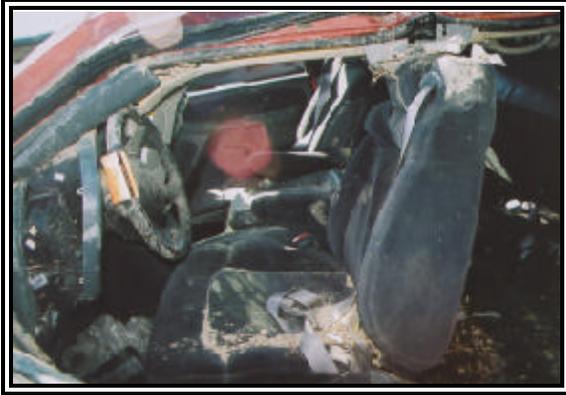
**Figure 10:** Left view of the driver's interior.

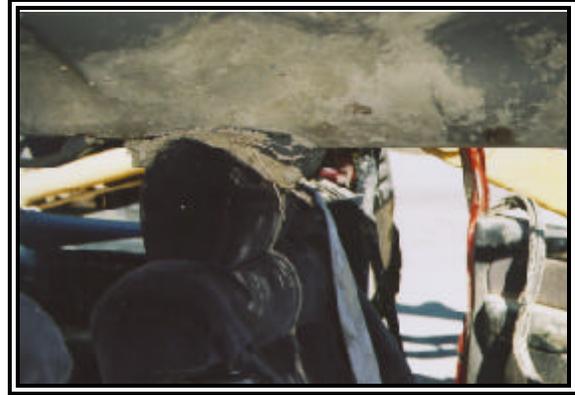
**Figure 11:** Right view of the driver's seat deformation.

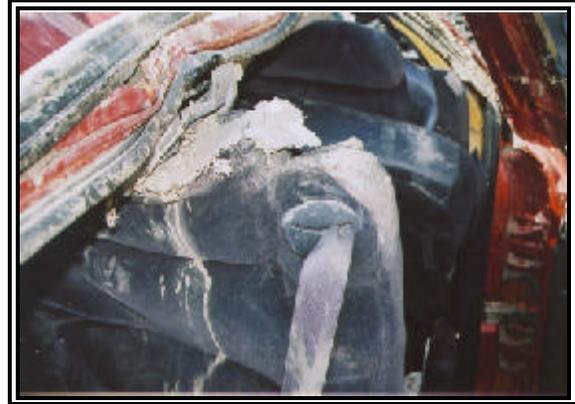
Inspection of the driver's restraint revealed the webbing was extended and the seat back mounted retractor was locked. The length of the extended webbing measured 138.4 cm (54.5 in). The latch plate exhibited minor evidence of historical use consistent with the age of the vehicle. The faint frictional abrasions were identified on the latch plate's plastic surface caused by the driver's inertial loading at lock-up. The webbing was gathered in the plastic belt guide located on the upper outboard aspect of the seat back, **Figure 12**. Inspection of the driver's restraint system indicated the driver was restrained at the time of the crash. The data downloaded from the vehicle's EDR reported the driver belt was buckled as well.

**Figure 12:** Driver webbing captured at upper outboard guide.

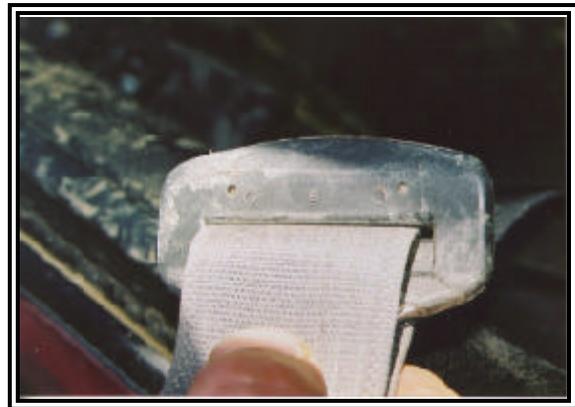
The condition of the front right passenger restraint was found to be similar to the driver's belt upon inspection. The webbing was extended from the retractor 130.6 cm (51.4 in) and the retractor was locked. The webbing was gathered in the plastic guide on the upper outboard aspect of the seat back indicating the webbing had been loaded by the passenger during retractor lock-up. The inspection of the latch plate revealed faint historical usage marks consistent with the vehicle's age. Subtle frictional abrasions were noted on the plastic belt guide caused by the passenger's inertial loading, **Figure 13**.

**Figure 13:** Frictional abrasions on the front right latch plate.

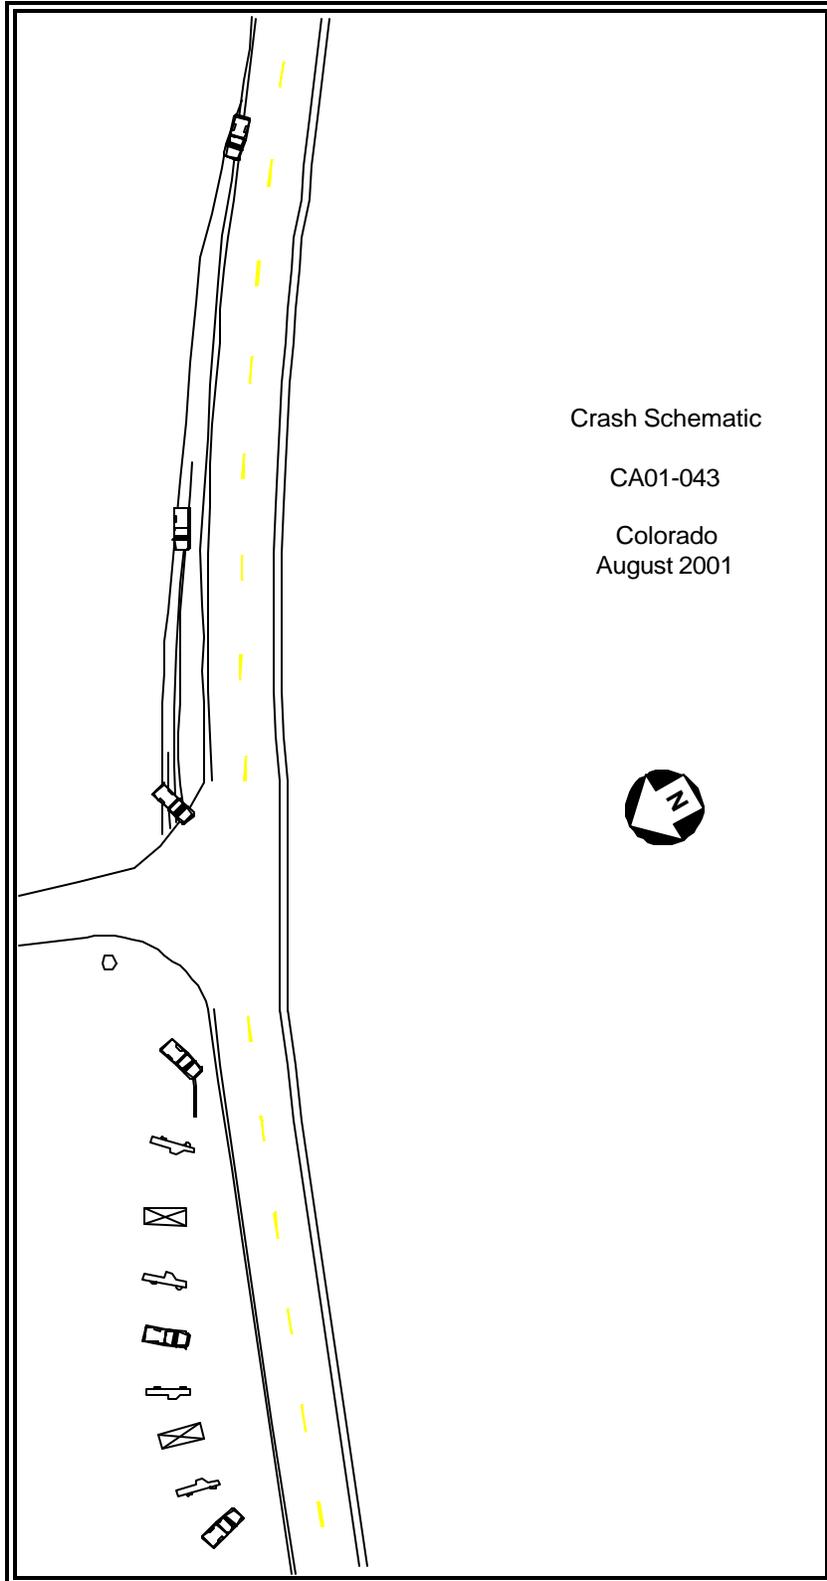
Figure 14: Crash schematic.

After the initial ground impact, the vehicle initiated a right side leading tripped rollover. The vehicle rolled 8 quarter turns (2 revolutions) over a distance of 57 m (189 ft). The Chevrolet came to rest on its wheels facing southward. A schematic of the crash is attached to the end of this report, **Figure 14**, page 10. During the second quarter turn, the vehicle impacted the ground with its roof and left side pillars (A/B/C). The left aspect of the roof crushed down and to the right. The driver's head impacted the roof during this sequence and he sustained an unspecified cervical fracture.

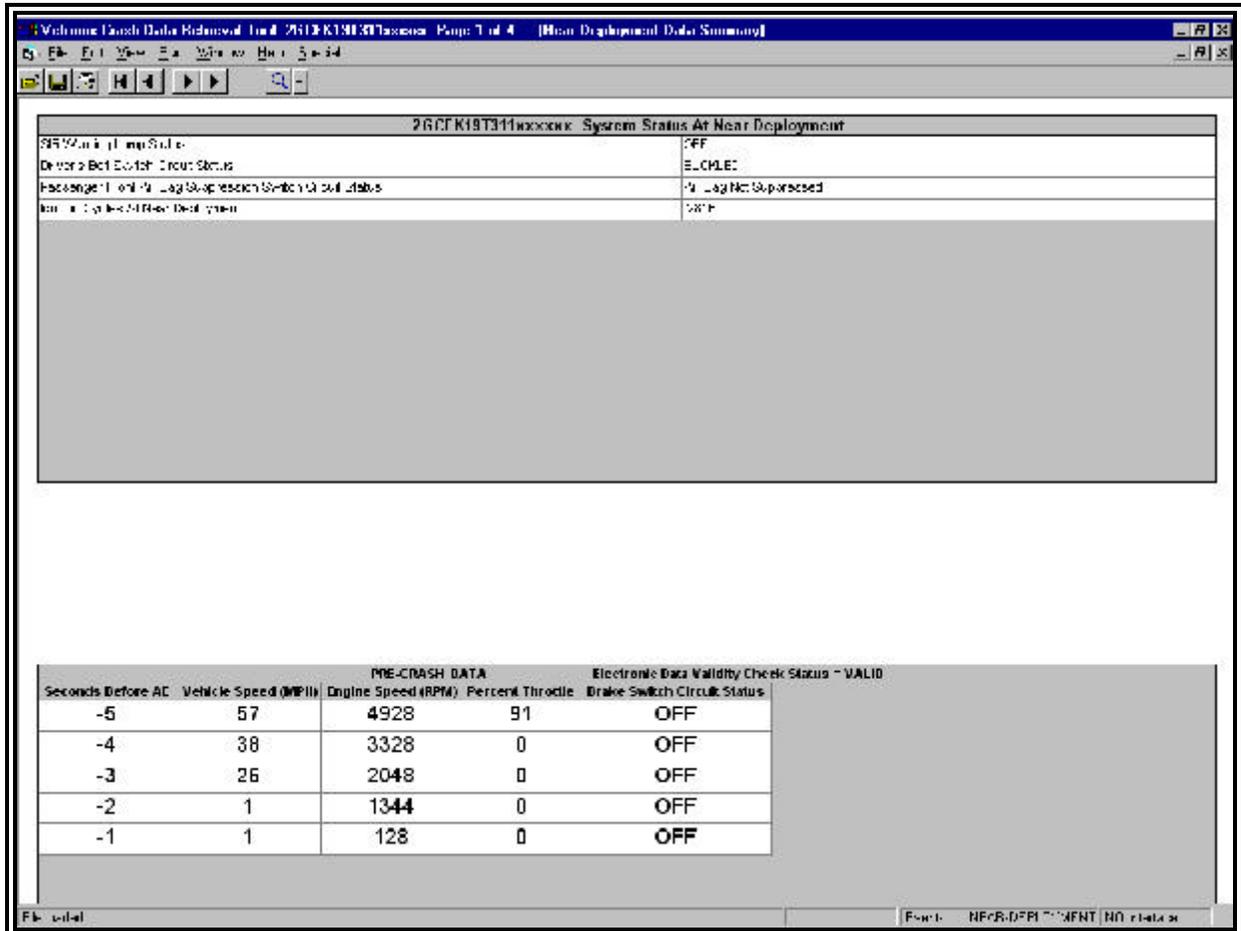
Figure 15: Near Deployment Data Summary

The EDR data was downloaded directly from the SDM during the SCI vehicle inspection. The EDR download results are included as an attachment at the end of this report, **Figures 15 and 16**. The data reported the driver's seat belt was buckled at the time of the crash. This buckled condition was confirmed by the SCI inspection. The pre-crash vehicle speed data was not useful for the purposes of crash reconstruction, due to the vehicle's yaw dynamics.
